Resetting the over temperature cut-out

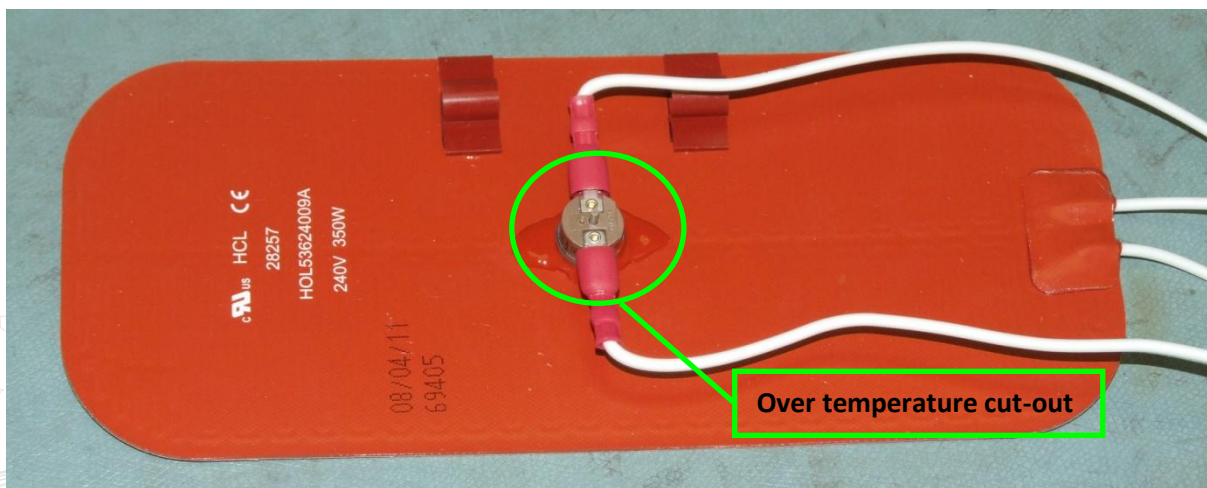
The bottom of the tank is now visible and on that is the heater mat (see below), in the middle of the heater mat is the cut-out. In the centre of the cut-out is a button this requires to be pressed in.

To reset the over temperature cut-out first remove all power and the water from the water bath. Then turn the unit upside down and remove the bottom cover, by removing the four or six screws (depending on the size of bath).

Refit the bottom cover and fit the original four or six screws removed.

If the cut-out has been tripped this will reset the bath and restore to normal operation. Ensure that the trip cause is known and corrected before further operation.
